REPORT NUMBER 110-GTL-05-003

**SAFETY COMPLIANCE TESTING FOR  
FMVSS NO. 110  
TIRE SELECTION AND RIMS**

**GENERAL MOTORS OF CANADA LTD.  
2005 BUICK LACROSSE, 4-DOOR PASSENGER CAR  
NHTSA NO. C50103**

FINAL REPORT

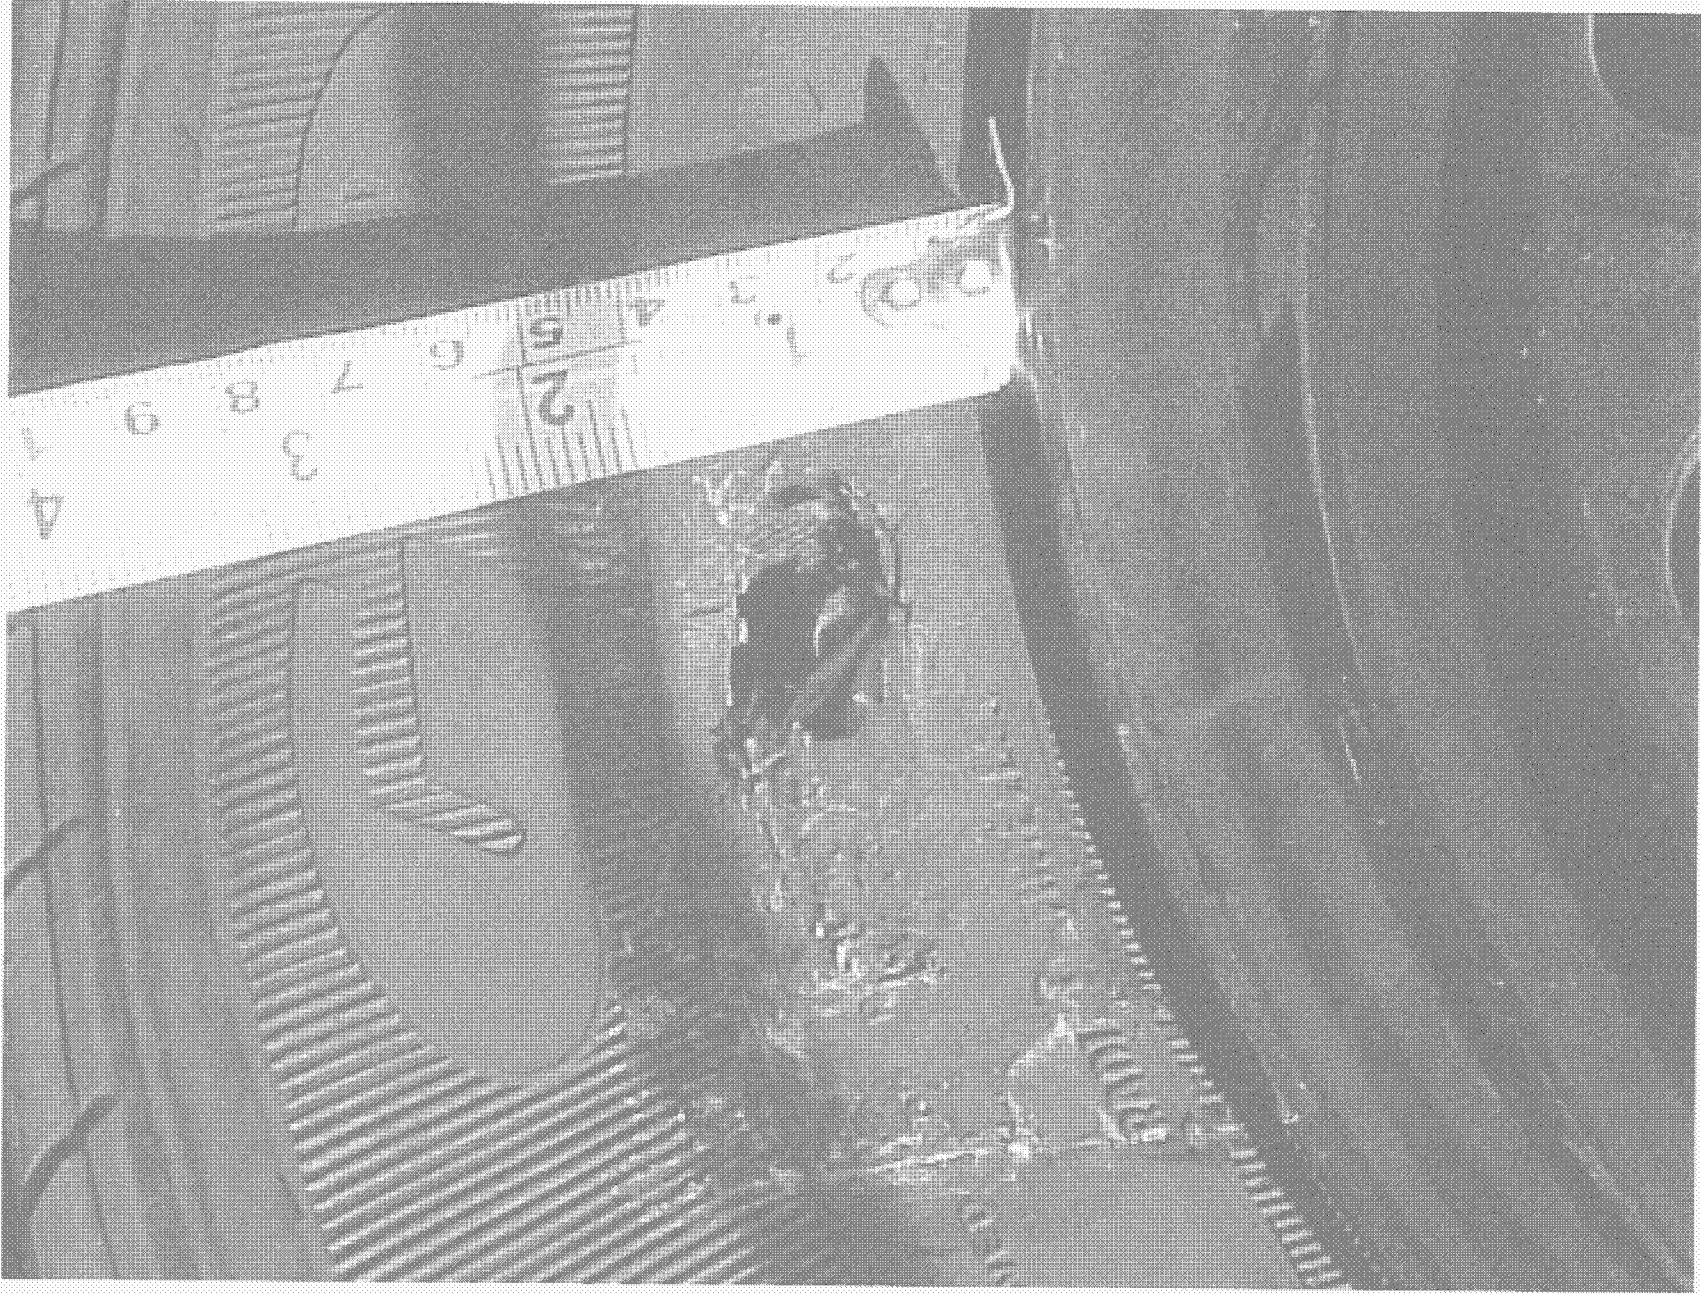
FIGURE 5.19  
CLOSE-UP OF BLOWN-OUT TIRE WITH RULER  
NEXT TO HOLE

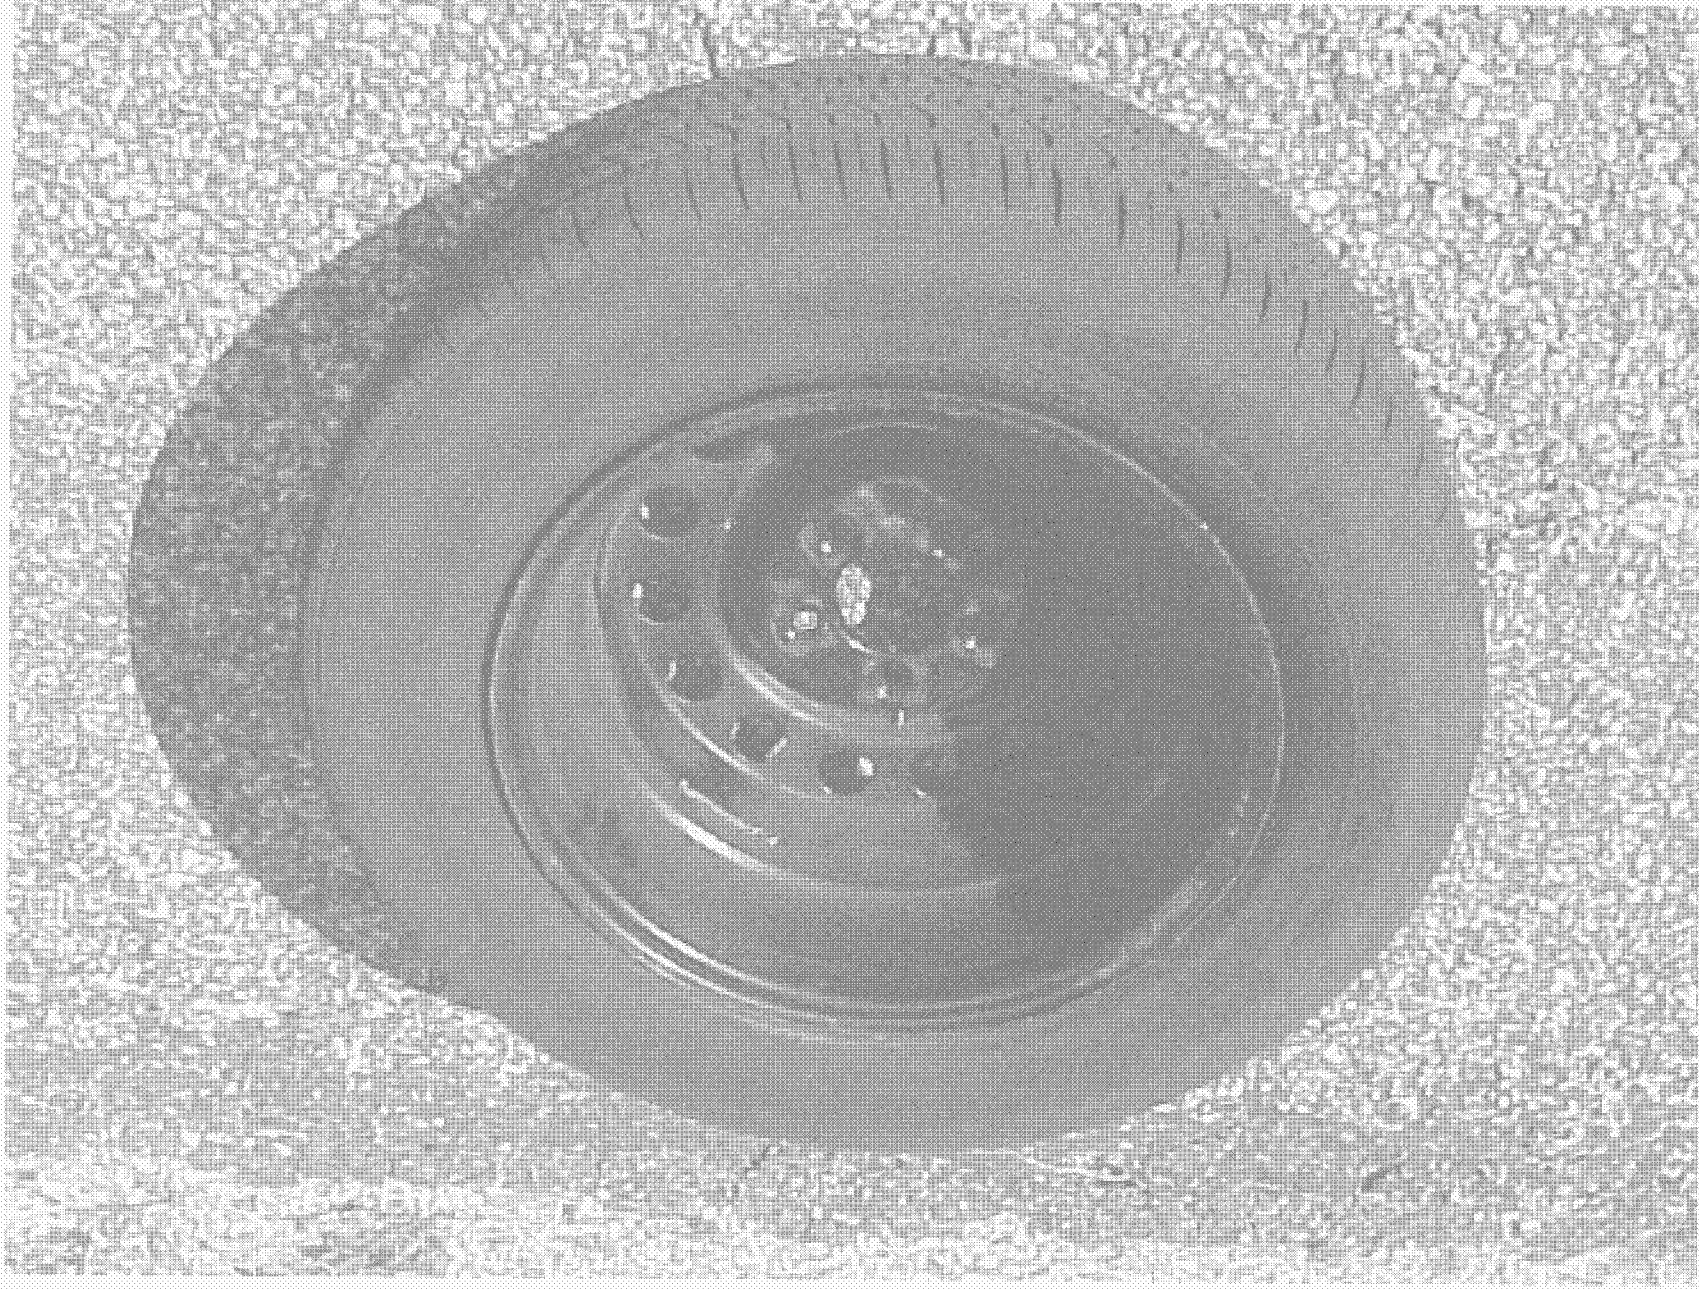
FIGURE 5.20  
INSIDE VIEW OF LEFT FRONT TIRE AFTER  
BLOW-OUT

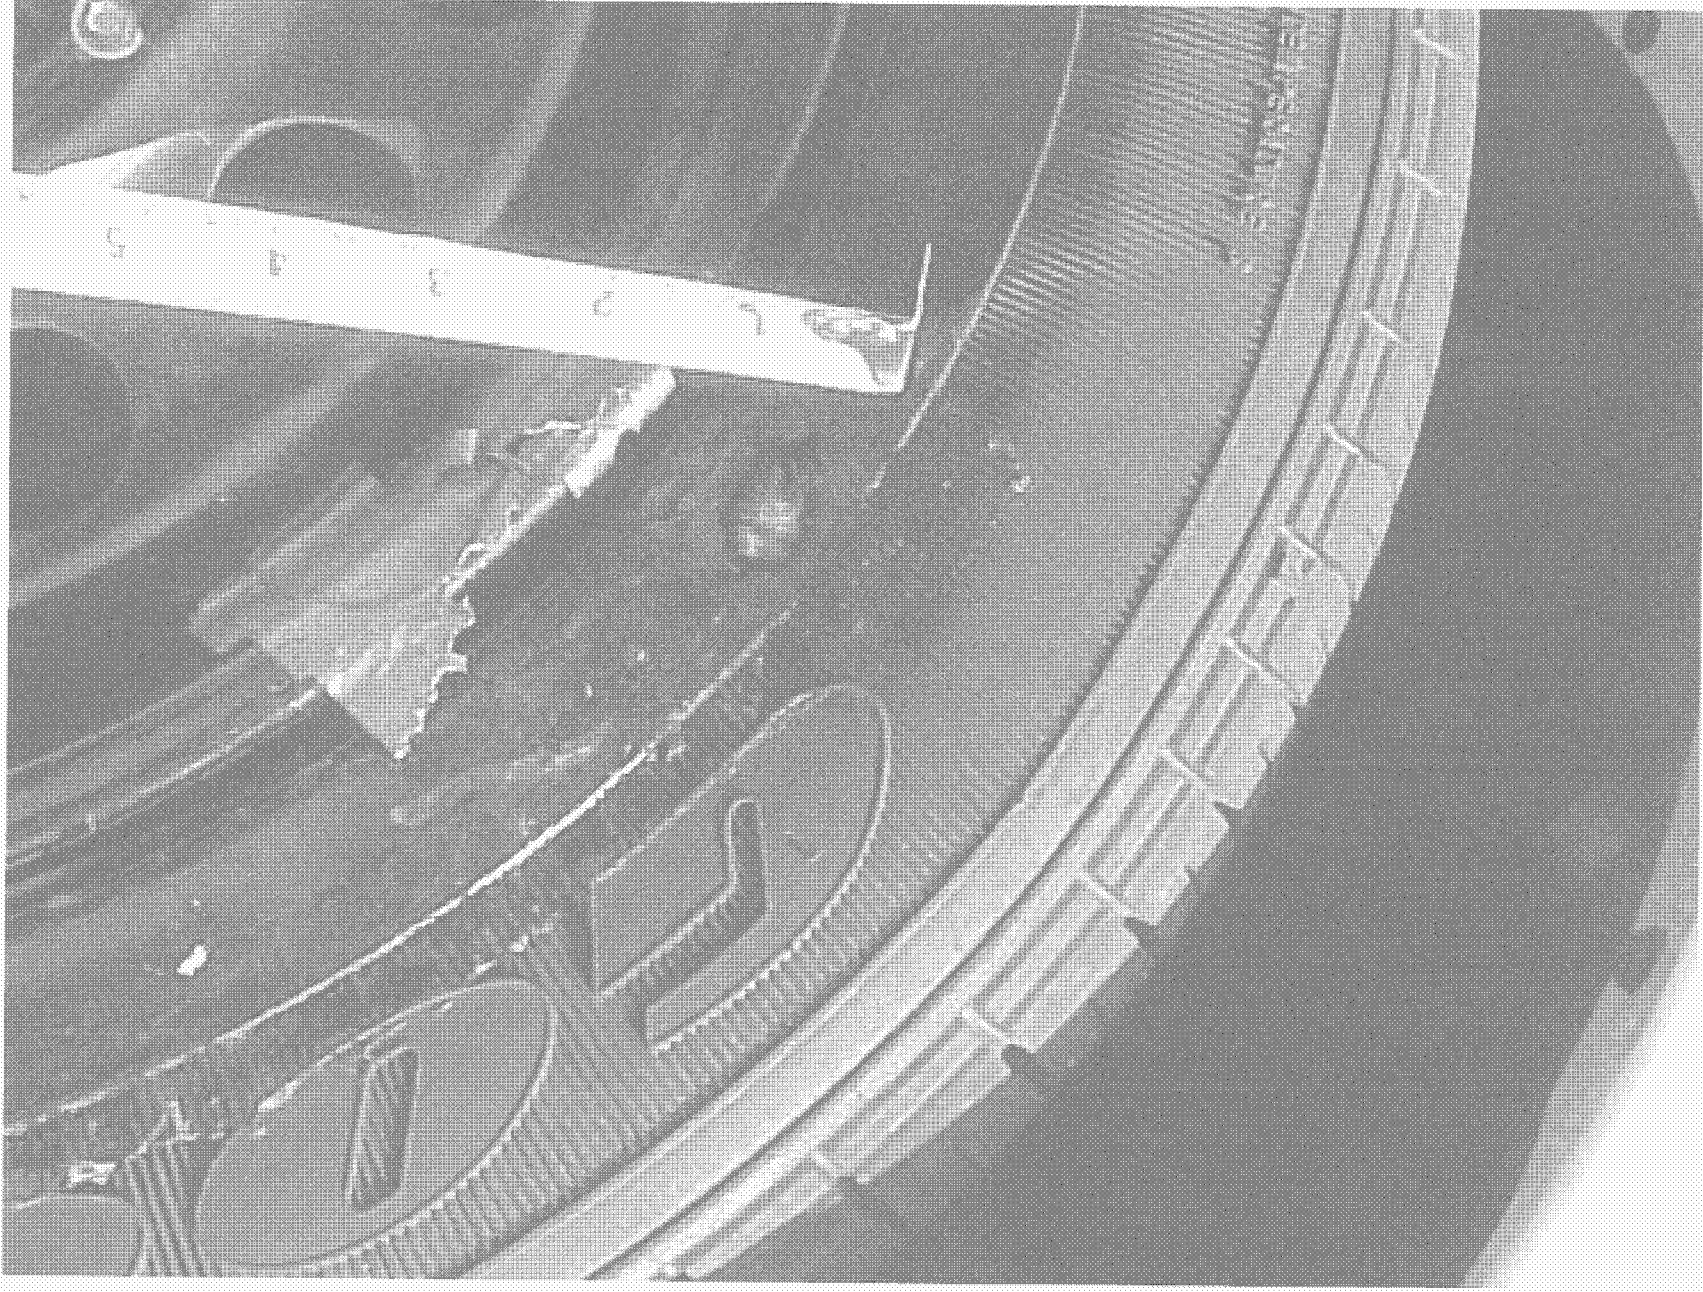
FIGURE 5.22  
CLOSE-UP OF BLOWN-OUT TIRE WITH RULER  
NEXT TO HOLE
